UTC3100 and 3170 POS RAID Information

Introduction

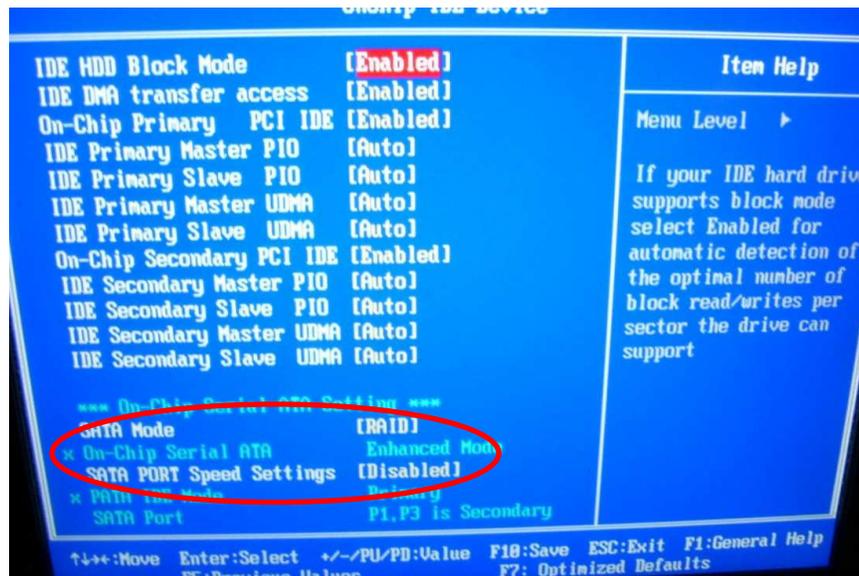
Figure 1, UTC3100 BIOS, RAID screen

UTC RETAIL RAID POS units are assembled with 2 identical hard drives (HDDs). When the POS is first booted at the factory, the boot screen identifies the two HDDs. The BIOS is accessed and the RAID functionality is enabled, as seen in the images below.

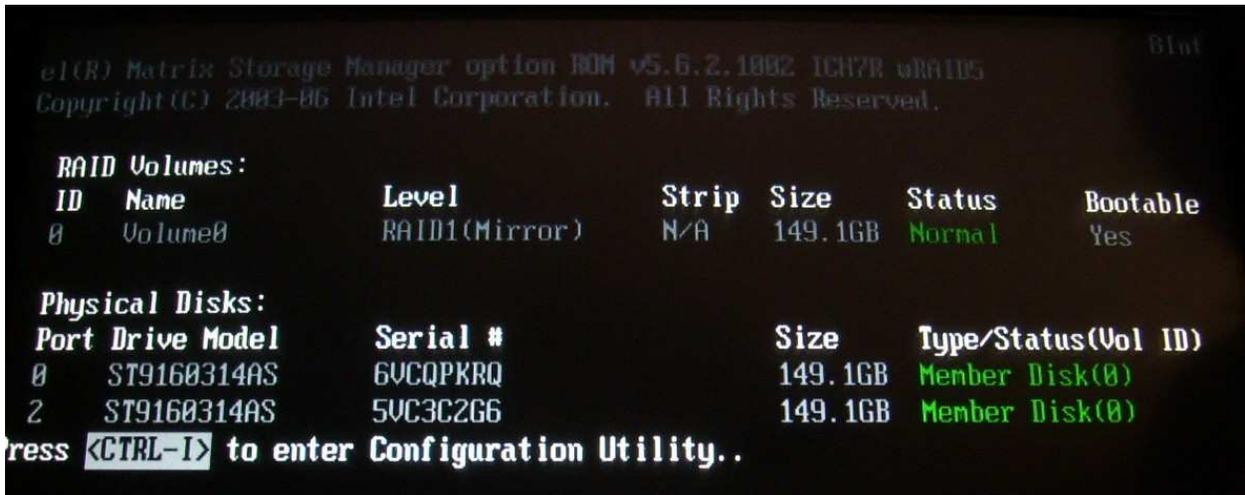
Figure 3, UTC3100 RAID screen

Seen below are Intel screens for the POS units after the RAID ROM has been configured. The two HDDs in the array have been configured to be Volume0, in a RAID1 setup. The two HDDs are identified to be Members of the Volume and the Volume status is Normal, meaning no errors have been detected.

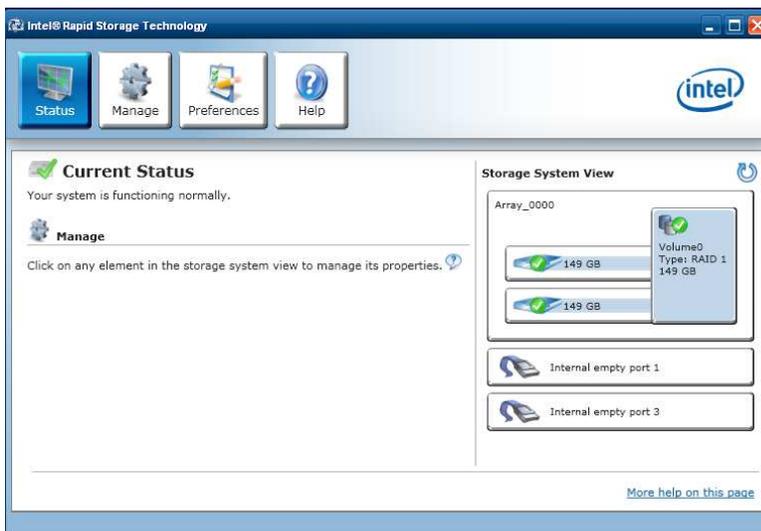
Figure 5, Array Function Normal

Right-click the check marked HDD, select Open Application and the Status screen of the Array is seen. The Array is identified as Volume0.

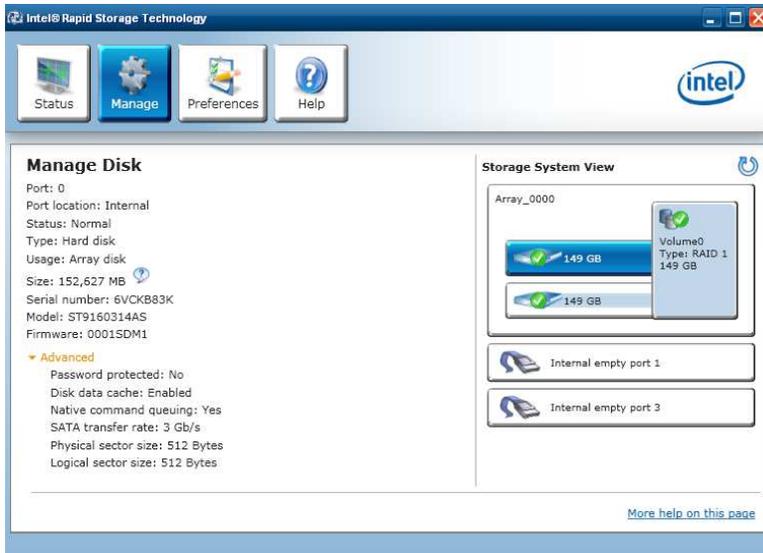
Figure 6, HDD Information

Select one of the HDDs on the Status screen, then select the Manage screen and information regarding the specific HDD can be found.

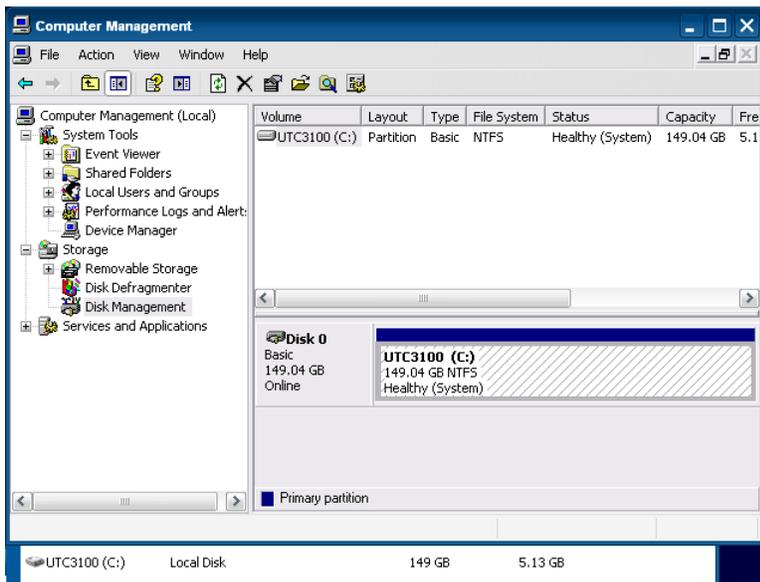
Figure 7, Disk Management and Explorer

Windows sees this Array as a single drive, as can be checked in Disk Management and Windows Explorer.

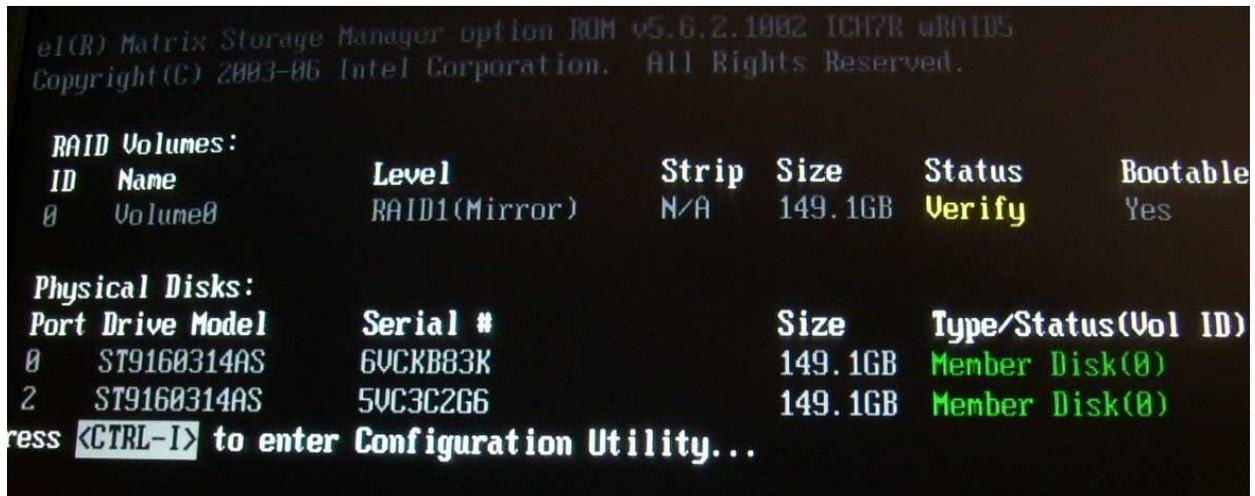
Figure 8, Volume0 in Verify Status

You may boot your system and find the Intel BIOS screen is telling you the Volume status is Verify.

The RAID volume data verification process identifies any inconsistencies or bad data on a RAID 1 volume. The RAID volume data verification and repair process identifies and repairs any inconsistencies or bad data on a RAID 1 volume.

RAID1	Verify	Verify and Repair
	Bad blocks are identified	Bad blocks are reassigned.
	Data on the mirror drive is compared to data on the source drive.	If the data on the mirror drive does not match the data on the source drive, the data on the mirror is overwritten with the data on the source.

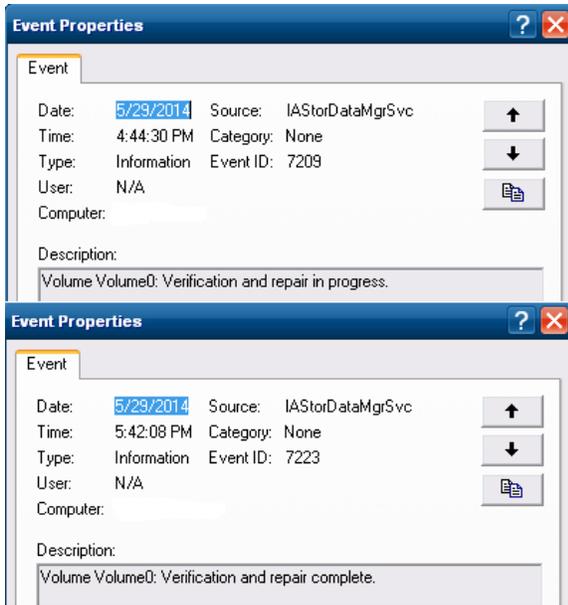
Figure 9, Application Event Viewer

The verification process can also be identified by review of the Event Viewer → Application log.

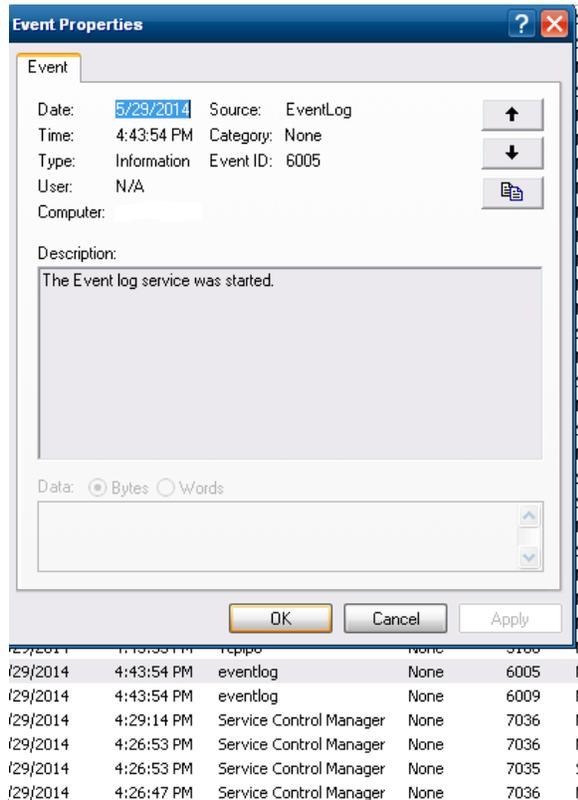
A system crash generally is the cause for the verification and repair need. A crash can be identified by inspecting the System Event Log. For example, this Event ID: 6005 shows the log starting up when Windows was started up. However, there is no previous Event ID: 6006, showing the log was shutdown when Windows was shutdown. The only reason Windows did not shutdown the log was because there was a power loss, causing Windows to crash.

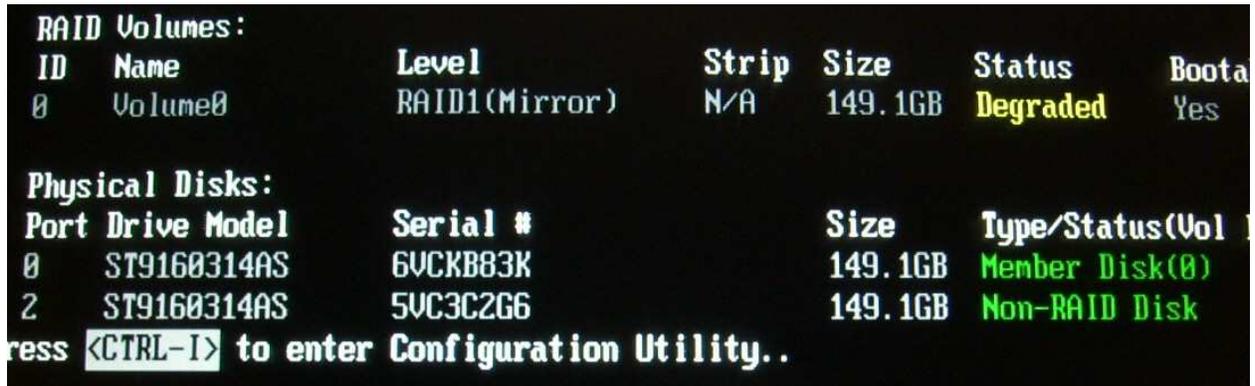
Figure 10, RAID Degraded

If a HDD is changed in the array, the Intel ROM software will indicate the RAID Volume is degraded:

```
RAID Volumes:
ID   Name           Level           Strip  Size   Status   Boota
0    Volume0       RAID1(Mirror)  N/A   149.1GB Degraded Yes

Physical Disks:
Port Drive Model   Serial #       Size   Type/Status(Vol
0    ST9160314AS    6VCKB83K      149.1GB Member Disk(0)
2    ST9160314AS    5VC3C2G6      149.1GB Non-RAID Disk

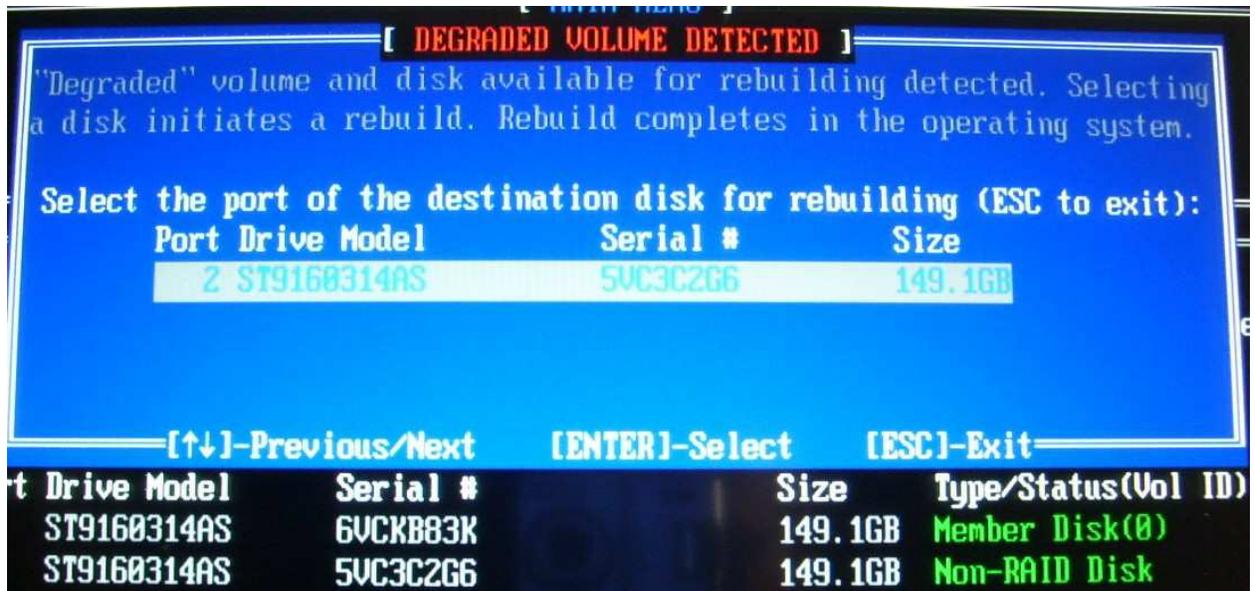
Figure 11, Add HDD to the Volume

A RAID volume exists, but a HDD in the volume was replaced and upon restart, the software detects this change. When the Configuration Utility is accessed the new HDD may be added to the volume.

```
[ DEGRADED VOLUME DETECTED ]
"Degraded" volume and disk available for rebuilding detected. Selecting
a disk initiates a rebuild. Rebuild completes in the operating system.

Select the port of the destination disk for rebuilding (ESC to exit):
Port Drive Model   Serial #       Size
2 ST9160314AS      5VC3C2G6      149.1GB

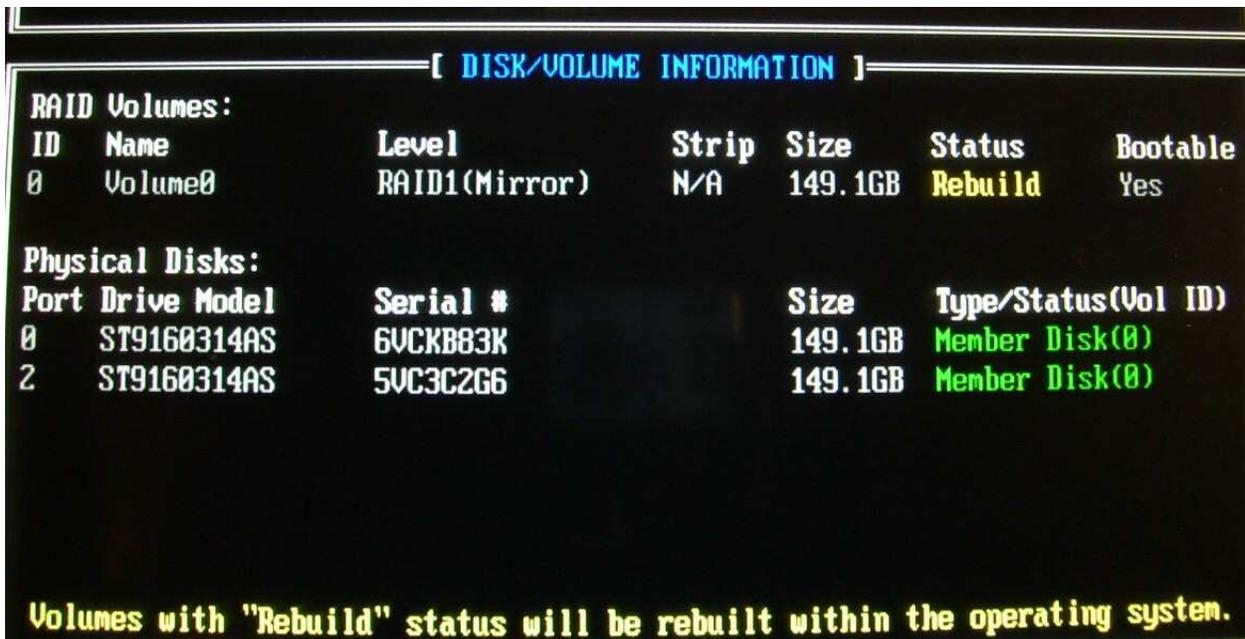
Figure 12, Volume with Rebuild Status

After the HDD is added, the software indicates the Volume must be rebuilt and it will be performed within the Operating System.

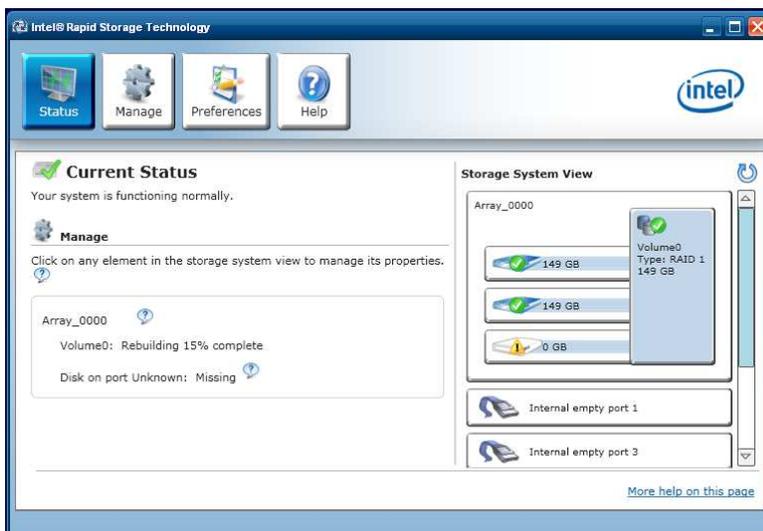
Figure 13, Volume Rebuilding

The System Tray icon for the Intel RST software will show an hourglass indicating an action is taking place. Open the software and the status screen gives information about the rebuild.

The software reports: "Your system is functioning normally.". This indicates the system is up and running, and the RAID1 process is operating correctly. To the right two HDDs have a green checkmark and one HDD shows a yellow exclamation point. The two checkmarks indicate the two HDDs in the volume area functioning OK, the yellow exclamation point is referencing the HDD that is "missing". To the left is the message the volume is rebuilding and when it is completed, the software will inform you.

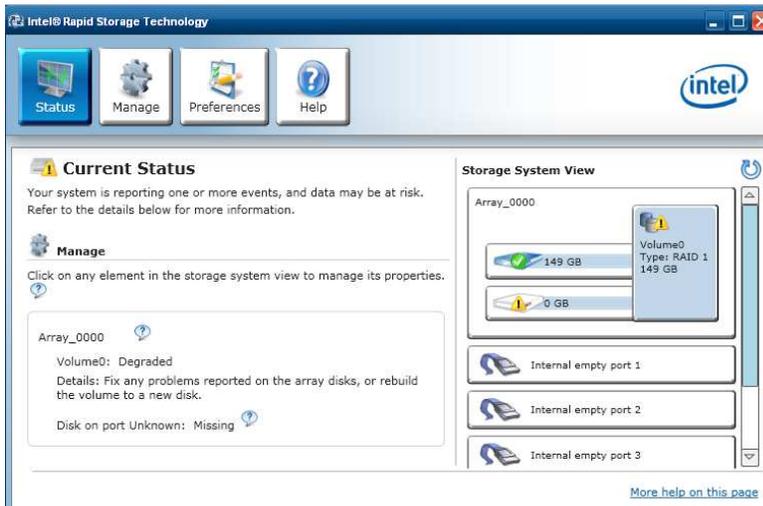
Figure 16, HDD Failure

When a HDD fails, it may appear to the system that it is missing. To repair the system, make a complete backup of the data on the system and then contact UTC RETAIL to arrange a system repair.
